SR 14 AND DOG MOUNTAIN CONGESTION AND SAFETY STUDY Dog Mountain Concept Refinement

Contract No. DTFH7015D00002, Task Order No. 69056720F000058: WA DOT 14(4), Congestion and Safety Mitigation Plan WA DOT 14(3), Dog Mountain Trailhead Study

Prepared for: Western Federal Lands Highway Division

Prepared by: David Evans and Associates, Inc. 2100 South River Parkway, Suite 100 Portland, OR 97201

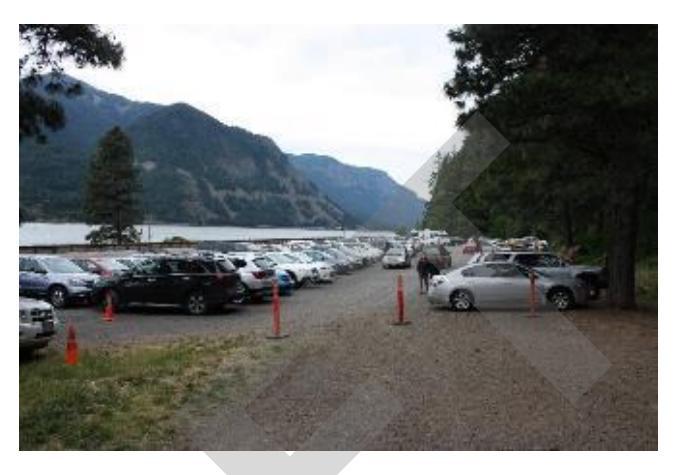
SR 14 Dog Mountain parking lot Source: USFS

The existing Dog Mountain Trailhead parking lot is located along the north side of SR 14 near milepost 54 with an uncontrolled ingress/egress approximately 600 feet wide. The parking lot is generally flat and at the same level as SR 14. There is a horizontal curve and steep topography east of the trailhead, which limits sight distance for vehicles traveling west on SR 14 and for vehicles attempting to turn onto SR 14 eastbound from the parking lot.

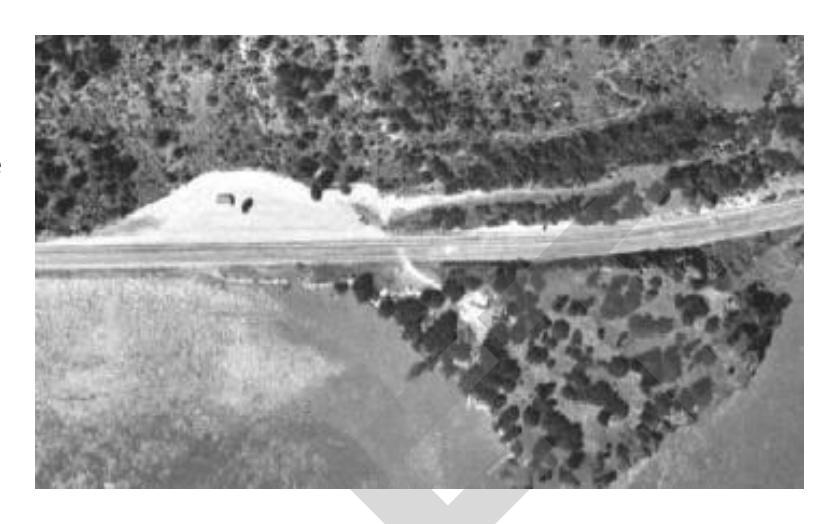
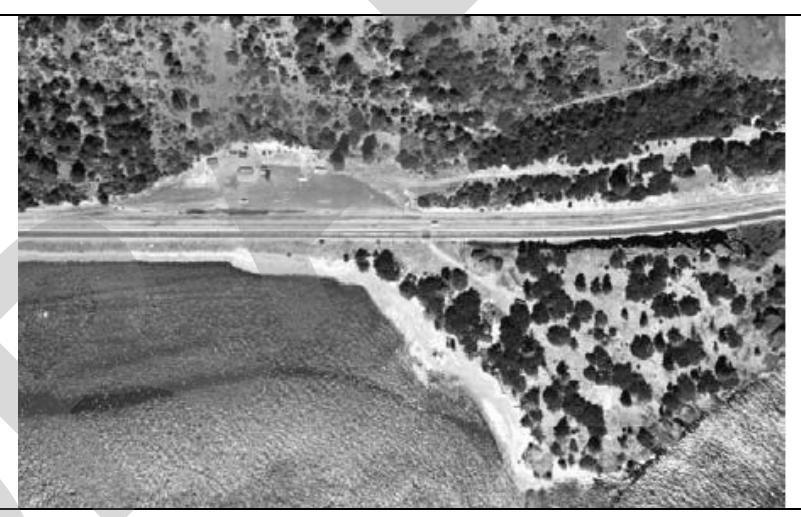
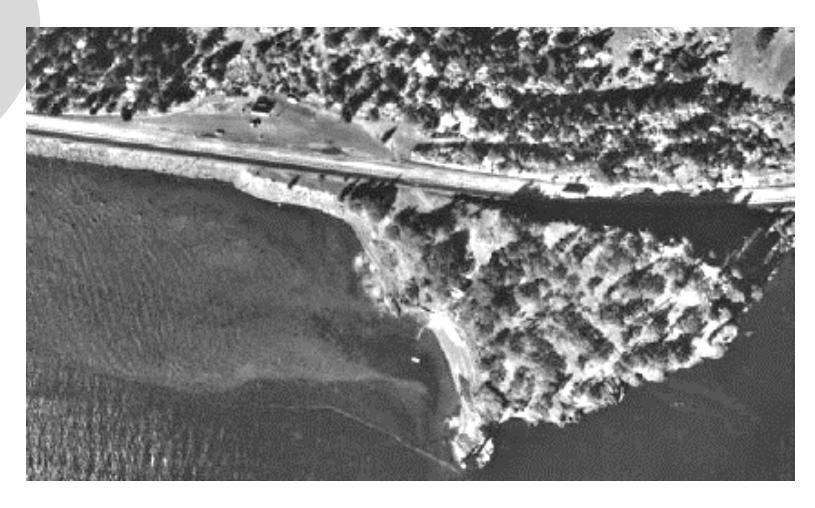
- 1948 The cleared area has been enlarged to approximate dimensions of the current parking lot. A structure is visible in the center of the site. Three vehicles are visible parked near the eastern end of the cleared area. A small structure is visible along the unpaved road at the eastern end of the site. Much of the wide strip of land adjoining the Columbia River has been eroded, leaving a point of land southeast of the project site. Buildings are visible on the point.

- 1957 Three additional structures are visible in the cleared around the central structure: a medium building to the northwest, a smaller building to the north and a small, elongated building to the east. Two cars are parked adjacent to the central structure which appears to be a commercial building. A beacon is present on the tip of the point. No significant changes were noted in the surrounding area.

- The small building at the 1968 north of the cleared area and the small, elongated building have been removed. Utility poles and an object that appears to be a flagpole are located in the cleared area. An object resembling a gas pump is present south of the central building. The building at the northwest border of the site appears to be commercial. Three cars and a larger truck are present. No significant changes were noted in the surrounding area.

Date	Comments	Aerial Photograph
1971	Four shed-like structures are visible along the eastern and northern border of the cleared area. Uncovered equipment is visible in the vicinity of these structures. Landscaping is visible surrounding the central building. Two objects resembling large trucks or mobile homes are visible near the western end of the project site. No significant changes were noted in the surrounding area.	
1989	All structures appear to have been removed from the project site. The unpaved dirt road appears to have become overgrown. Four vehicles are parked near the northern border of the cleared/parking area. No significant changes were noted in the surrounding area.	
1995	No significant changes were noted on the project site or in the surrounding area.

In February 2007, a report prepared for FHWA Western Federal Lands Highway Division (WFLHD) by GRI Geotechnical & Environmental Consultants summarized the historical use information of the existing site. GRI reviewed aerial photographs dated 1935, 1948, 1957, 1968, 1971, 1989, and 1995 obtained from the U.S. Army Corps of Engineers' Portland District office. Land use based on interpretation of the photographs is described below in Table 1.

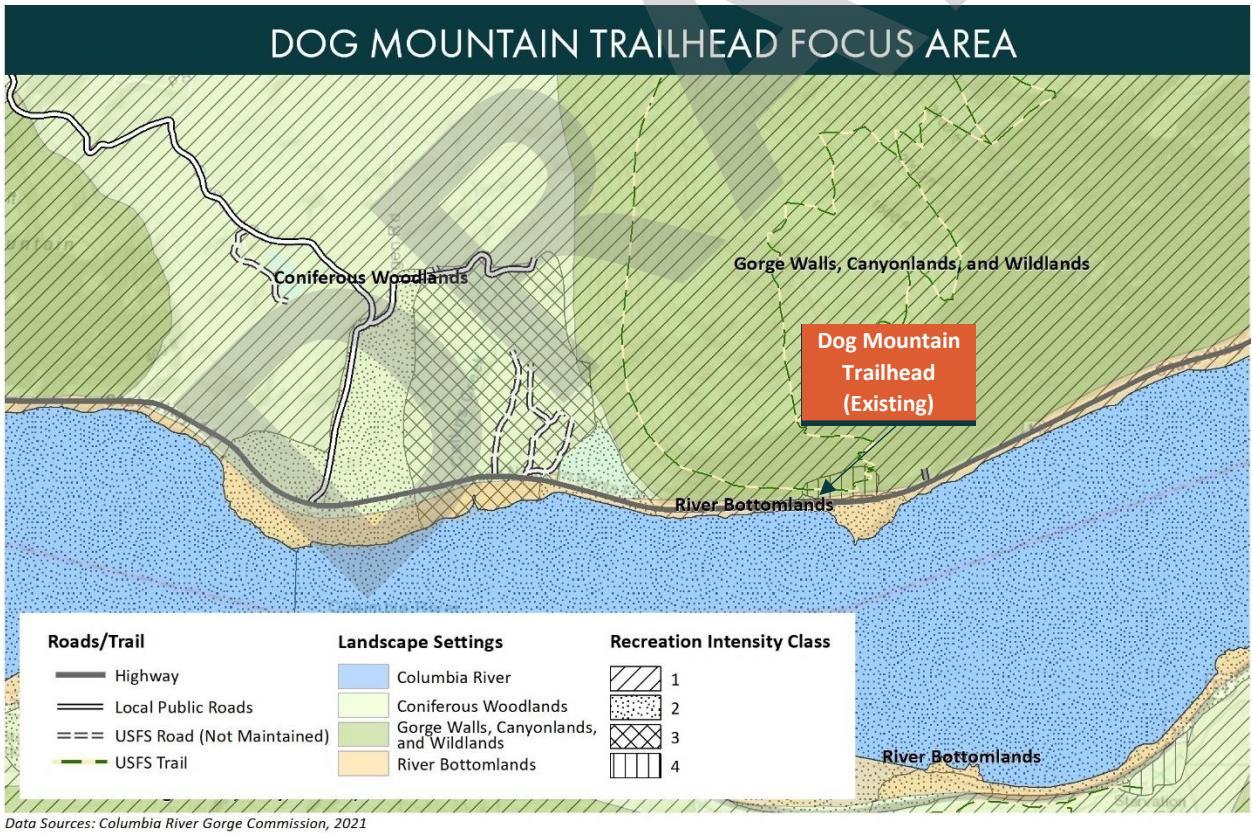
Figure 1. Land Use

The CRGNSA Management Plan further designates policies and provisions related to development for four "recreation intensity classes" (RIC) in General Management Area and Special Management Area lands. The RIC dictates the allowable recreation uses. A RIC of 1 indicates the area is suitable for very low intensity recreation and has more stringent guidelines than a RIC of 4, which indicates the area is suitable for high intensity recreation. Related to the potential trailhead and parking lot development or relocation, the RIC, as shown in Figure 1, will play an important role in alternatives development and selection. The existing parking lot spans RICs of 1, 2 or 4, which may limit the ability to improve the area in its current location and still maintain current capacity. The land that serves the parking lot also spans three separate owners: WSDOT, USFS and BNFS (shown in Figure 3, page 11).

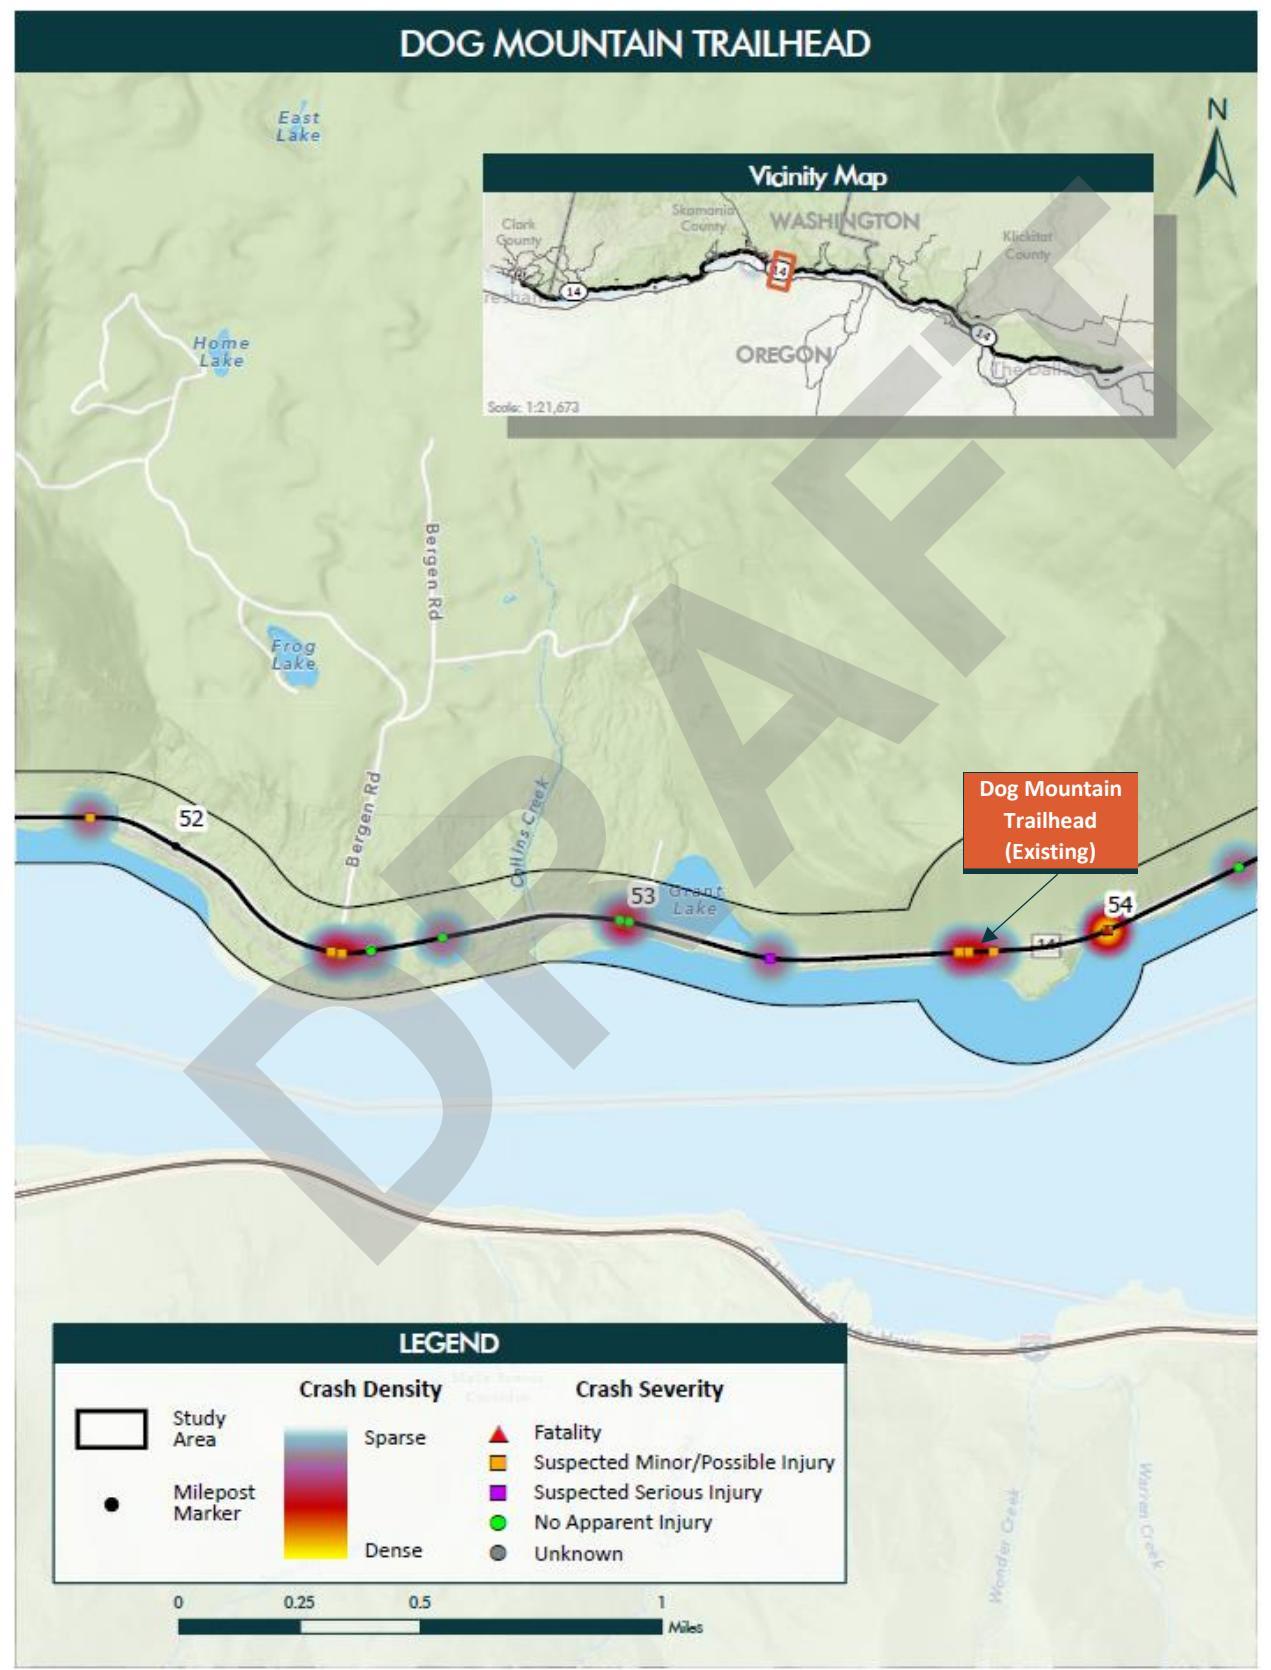
Figure 2. Dog Mountain Crash History (2015-2019)

As it relates to Dog Mountain trailhead focus area, the crash analysis reviewed crashes along SR 14 for MP 52.3 – MP 54.3, which are summarized in Table 2 and shown in Figure 2. There were 14 crashes reported in this segment within the 5-year analysis period, seven of which were within ½-mile east and west of the existing Dog Mountain trailhead parking lot.

Of those seven crashes within the influence area of the parking lot, one resulted in serious injury and one resulted in a fatality. The pedestrian crash resulted in the serious injury and the fatality was due to a rear end collision.

Current accident data was collected from the WSDOT between 2015 and 2019 as discussed previously in this report (Table 2 and Figure 2). Two crashes were reported between MP 52.8 – MP 53.3. The crash data does not preclude a left-turn lane; however, the collisions types were caused by a rock fall and an equipment failure, indicating a left-turn lane would likely not have prevented the collisions.

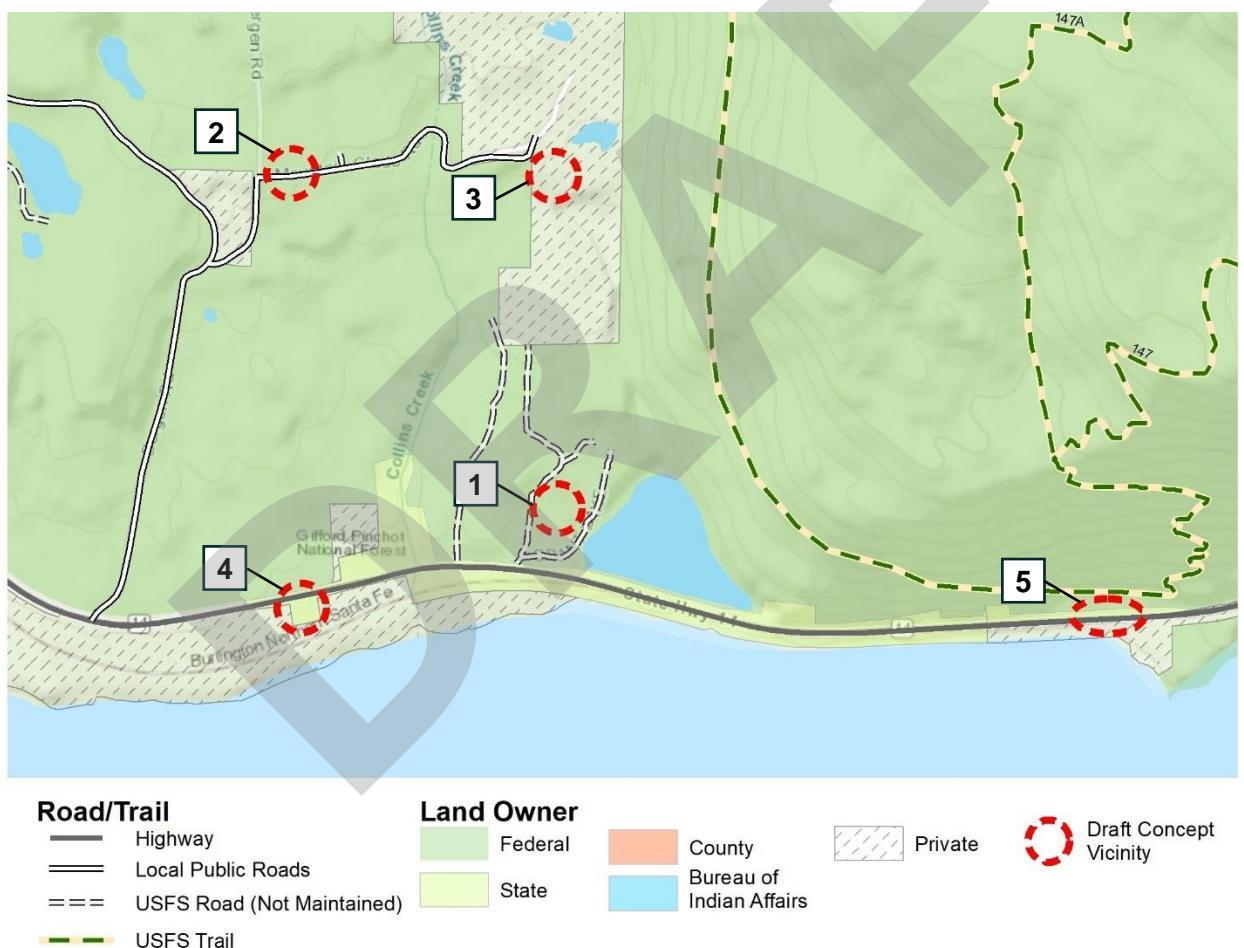
Figure 3. Draft Concepts Vicinity

Five locations for the Dog Mountain trailhead relocation were originally identified by the Consultant team through information available in the Federal Lands Access Program (FLAP) application and reviewing existing topography:

- 1. Grant Lake
- 2. Mountain Glade West
- 3. Mountain Glade East
- 4. Maintenance Yard
- 5. Existing

The general location of these sites is depicted in Figure 3.

The five conceptual locations shown in Figure 3 were distributed to the Core Project Team (CPT) to share with their respective staff for preliminary feedback. The intent was to screen out any concepts unlikely to be implemented due to "red flags", such as whether it makes progress toward addressing the project purpose or if the agencies have other jurisdictional concerns. The feedback aided the project team in determining whether that deviation was substantial enough to remove the concept from further consideration or warrant refinement before more detailed analyses are completed.

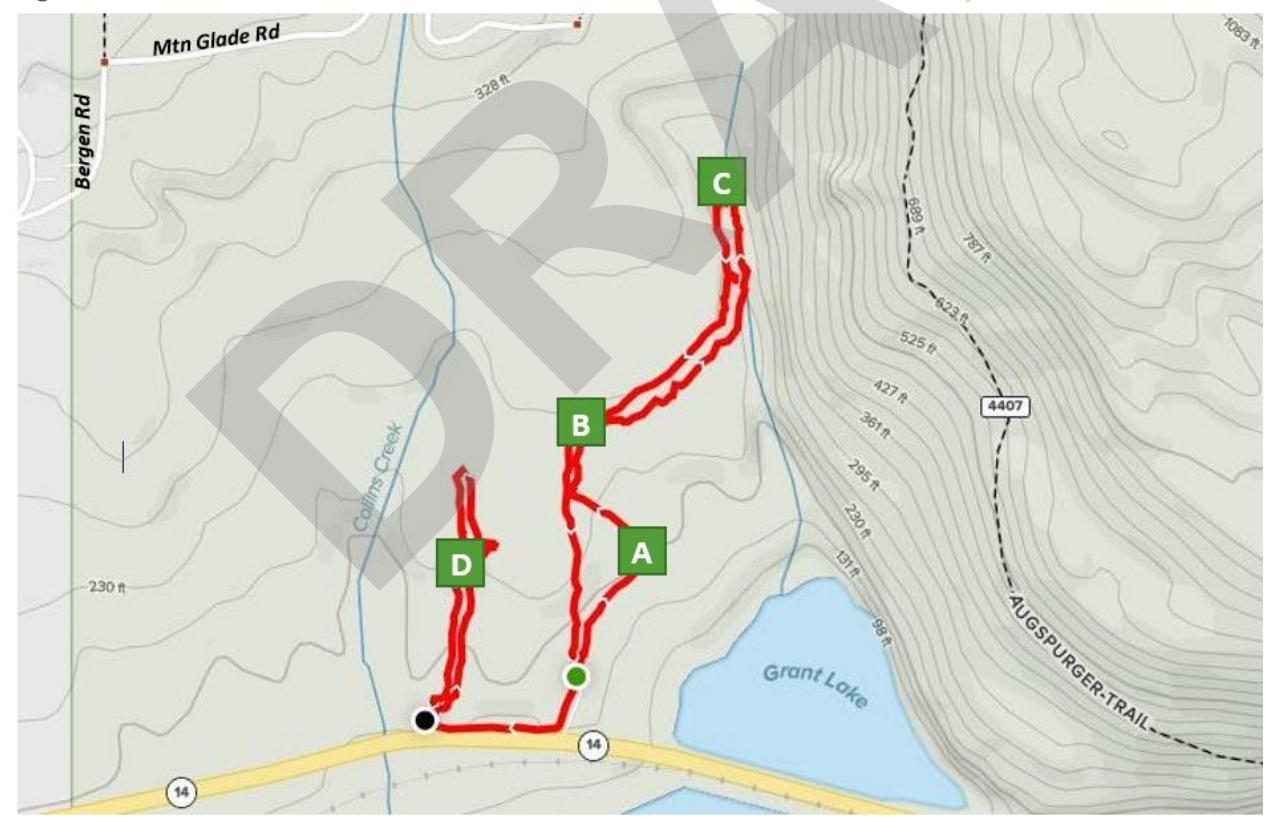
Figure 4. Site Visit Route

As a follow-up to the concerns expressed during the preliminary screening, the Consultant team organized a site visit on Tuesday July 27, 2021 with USFS natural resource and recreation staff to further vet potential site locations in the area west and north of Grant Lake, as shown in Figure 4. The findings are summarized below, and the detailed notes are provided in Attachment A.

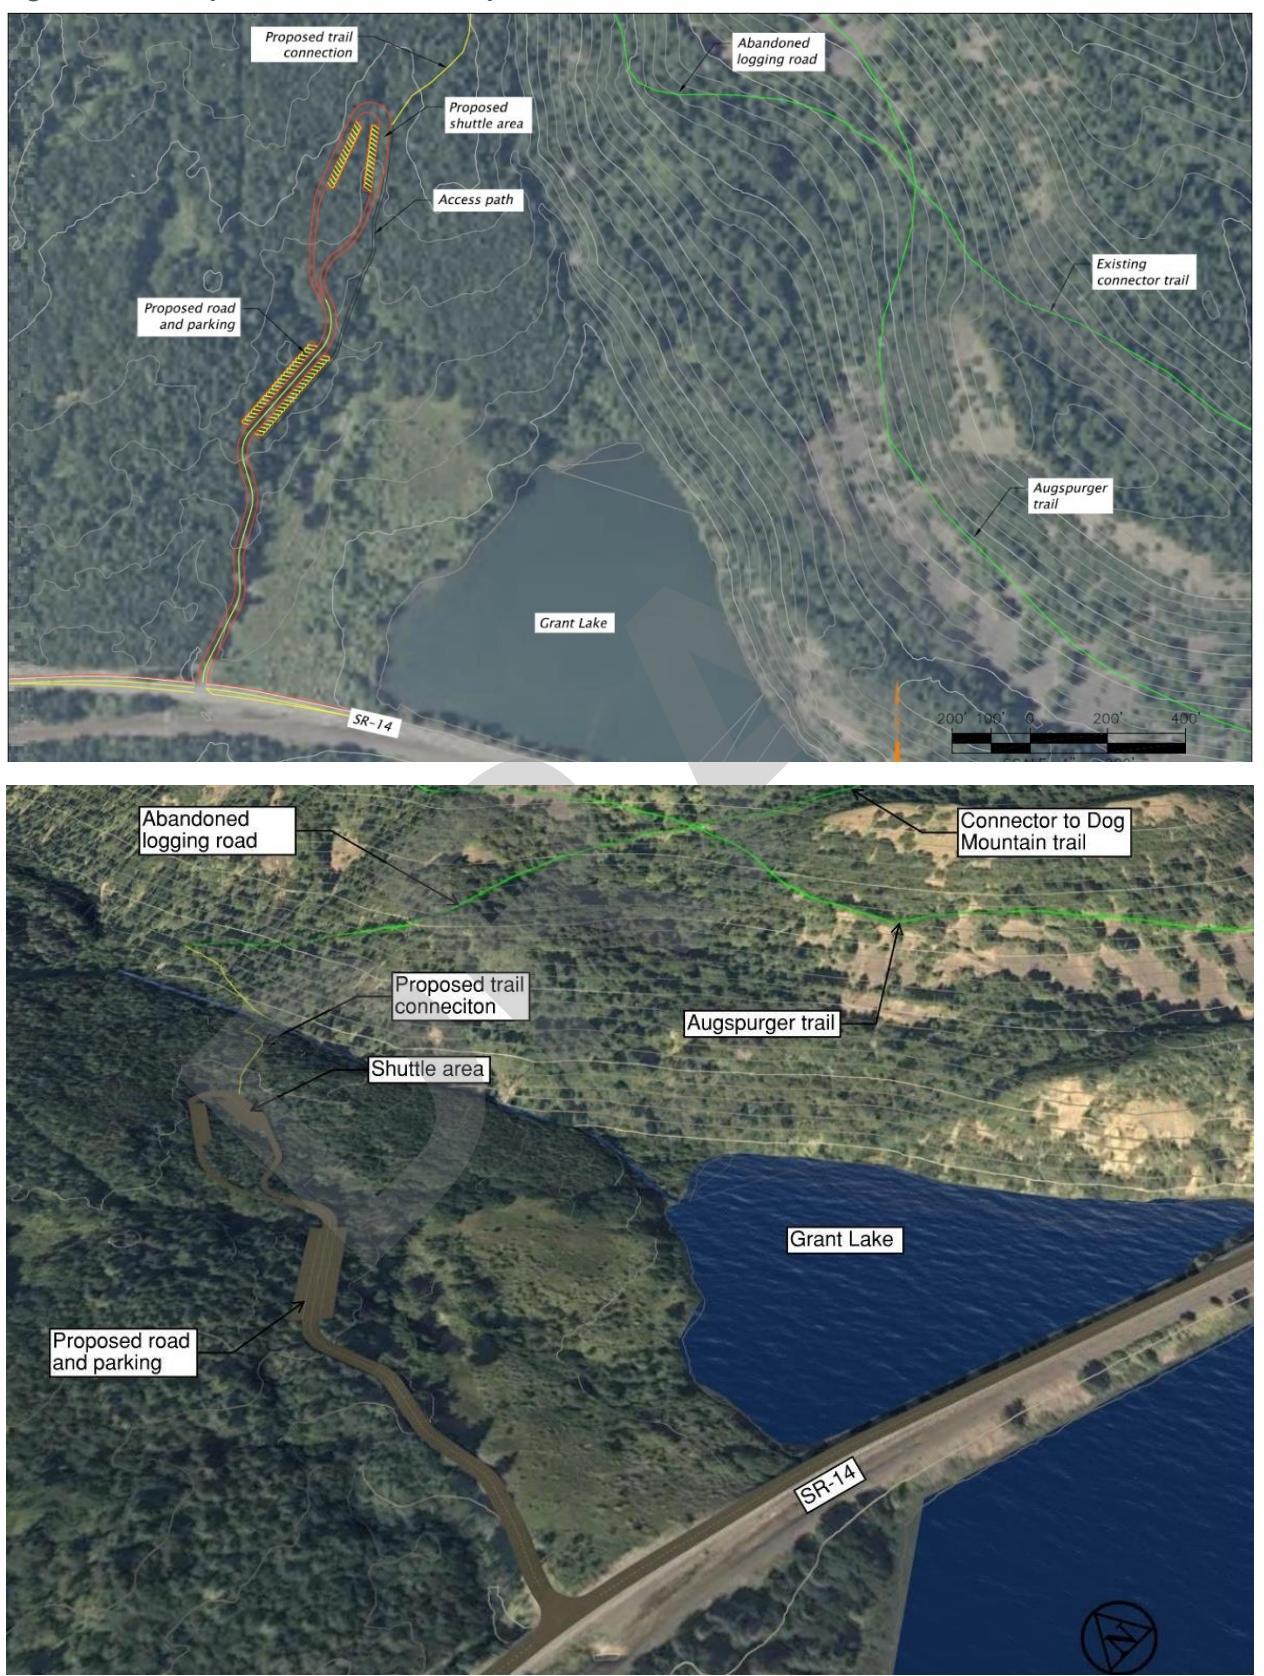
Figure 5. Concept 1: NW Grant Lake Sprawl

This concept is depicted in Figure 5. The distinguishing feature of this concept is that its northern lot minimizes the distance between the parking lot and the existing trail system.

The preliminary rough order of magnitude cost estimate for Concept 1 ranges from \$1.8 million to \$2 million, depending on design features, and includes a 40% contingency for construction costs (2021 dollars). If design, project management and construction engineering design support is needed, the estimate increases to a total of approximately \$2.4 to \$2.6 million.

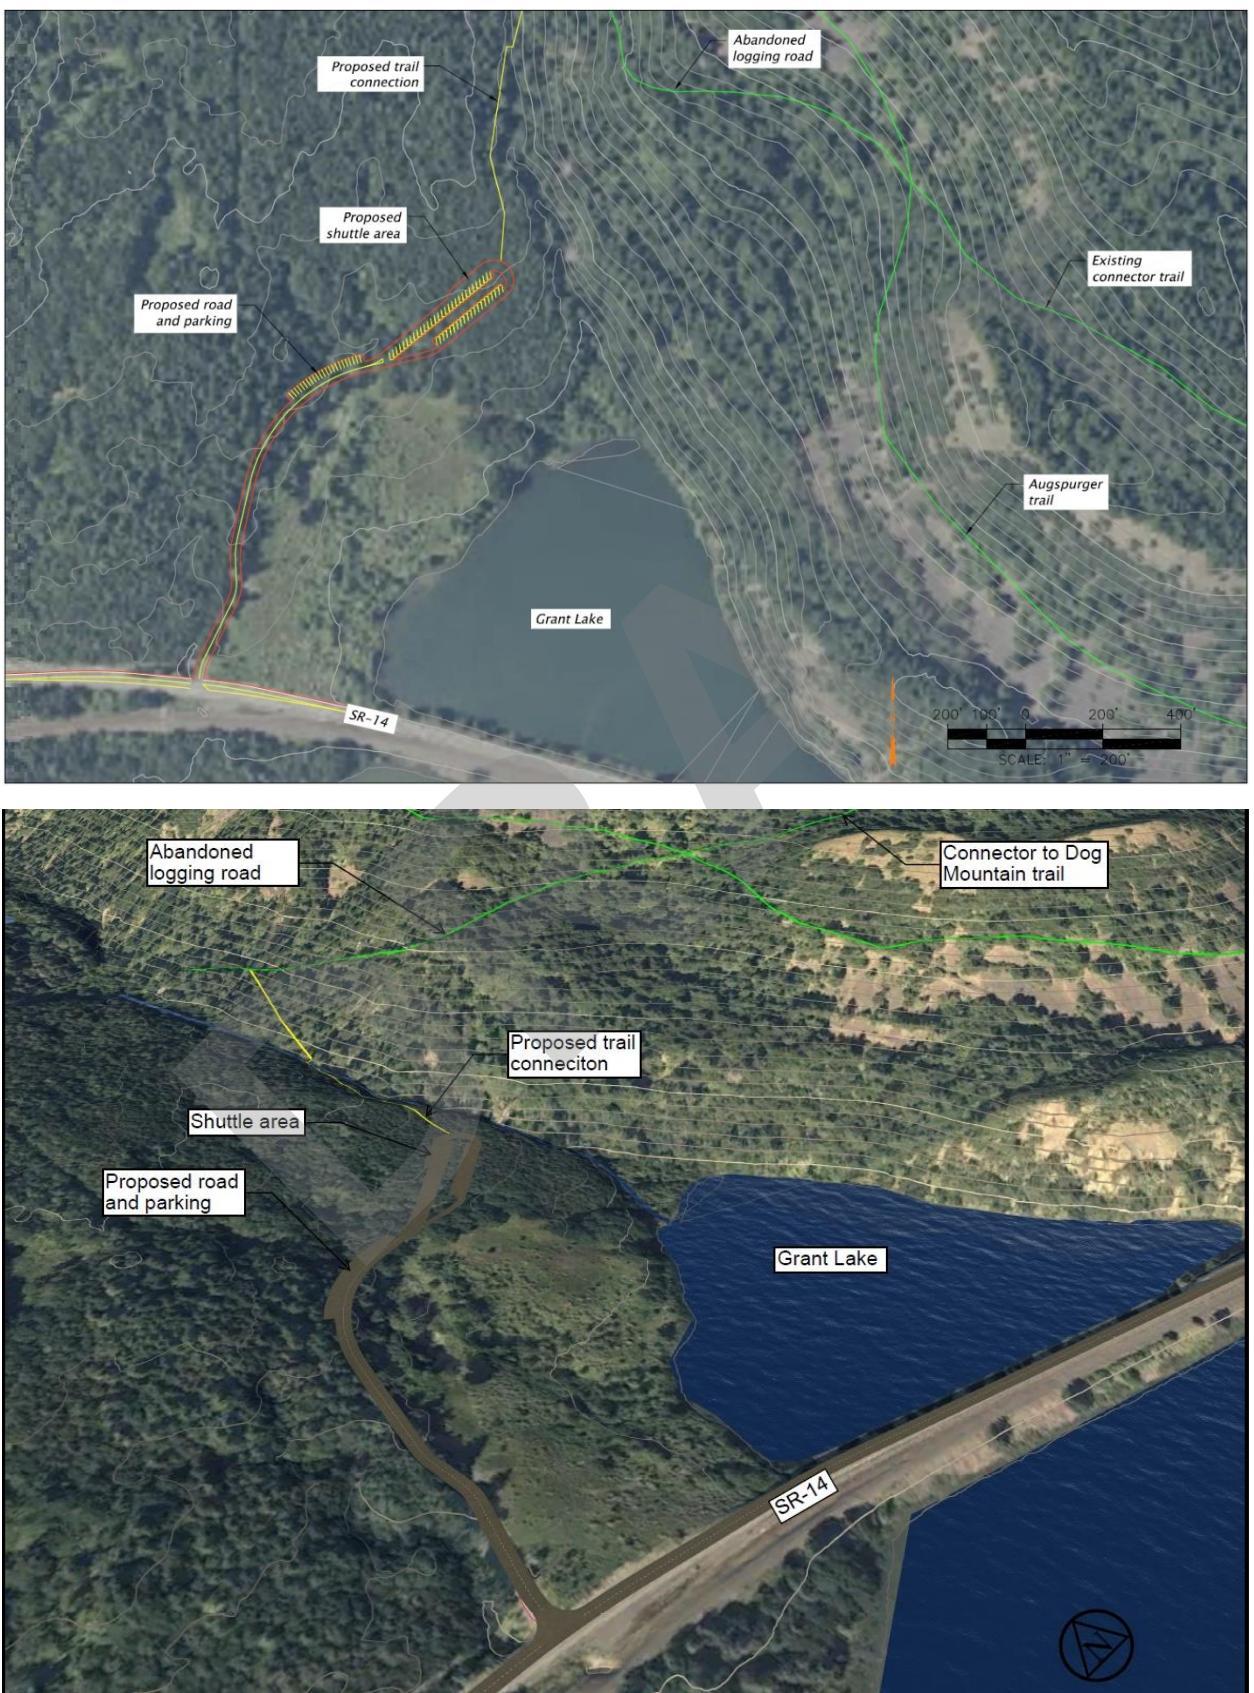
Figure 6. Concept 2: NW Grant Lake Compact

The preliminary rough order of magnitude cost estimate for Concept 2 ranges from \$1.5 million to \$1.7 million, depending on design features, and includes a 40% contingency for construction costs (2021 dollars). If design, project management and construction engineering design support is needed, the estimate increases to a total of approximately \$2 million to \$2.2 million.

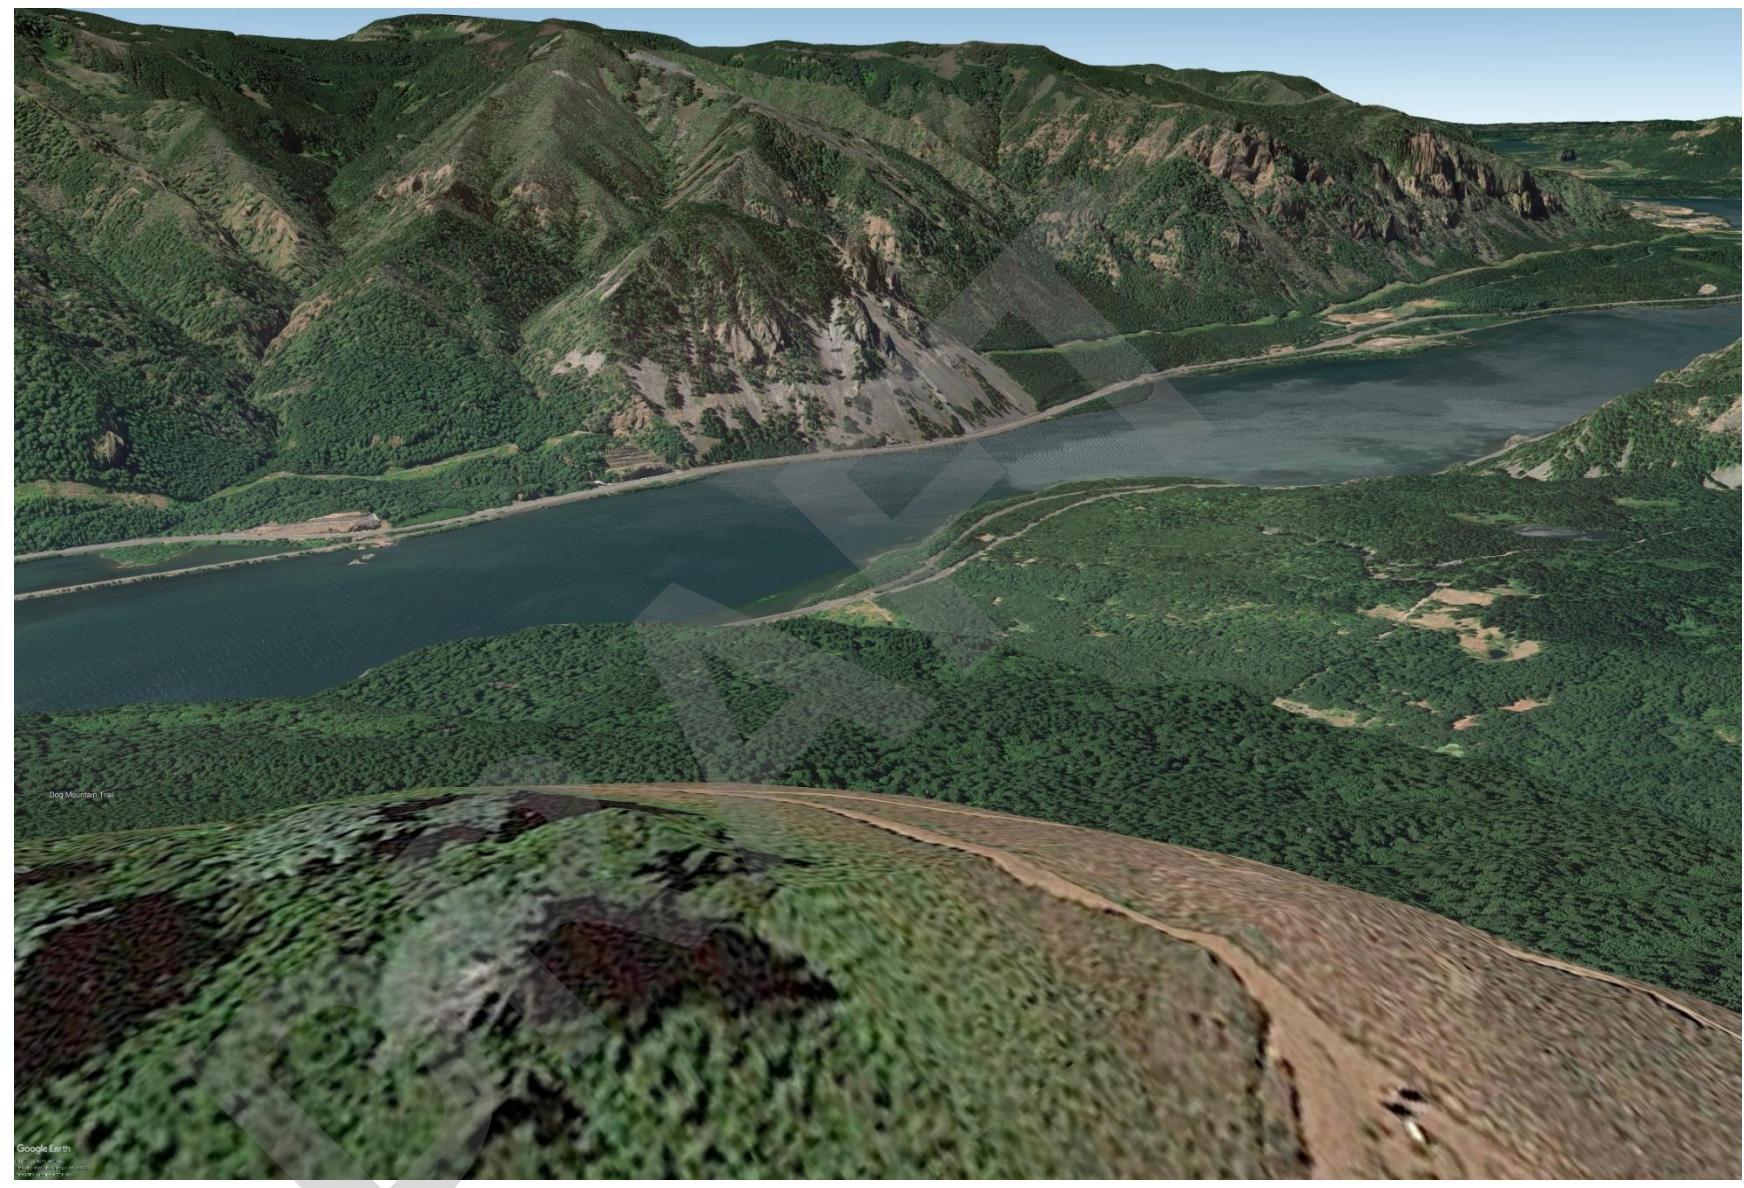
Figure 7. Existing Preliminary Visualization from Dog Mountain Trail Summit

The DEA team developed preliminary conceptual visualization of Concept 1 and Concept 2 from the Dog Mountain Trail Summit. Figure 7 depicts the view under existing (No Build) conditions, facing southwest toward Grant Lake from the Dog Mountain Trail Summit. Figure 8 depicts Concept 1 from the same viewpoint. The southern parking lot is just visible, as the ridge hides most of the parking lot's footprint. Figure 9 depicts Concept 2, which is even less apparent than Concept 1.

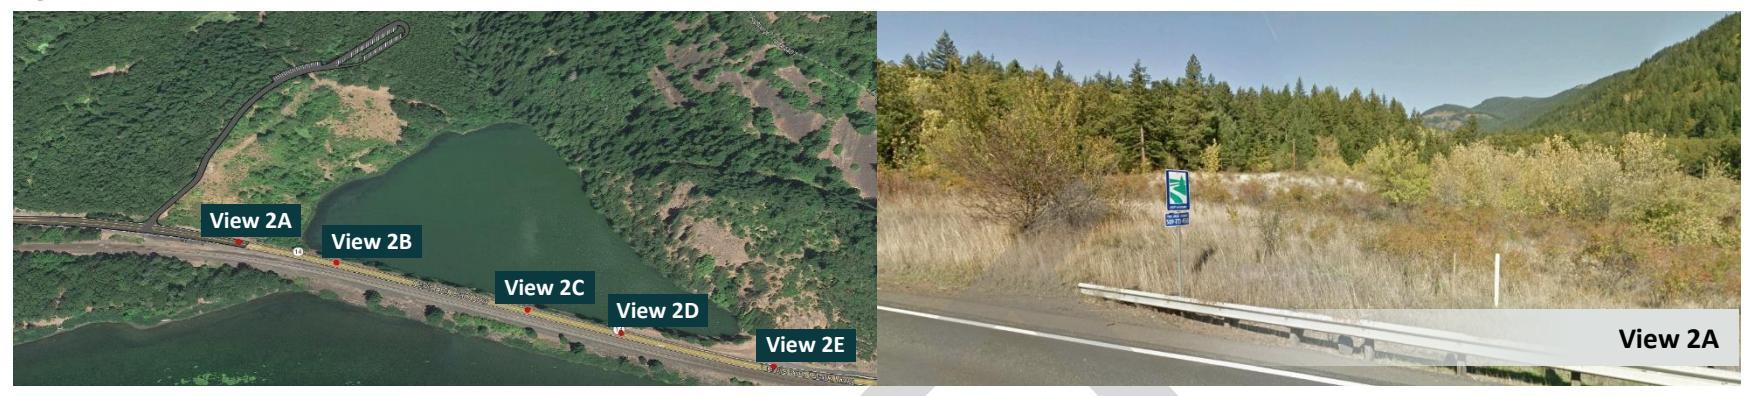
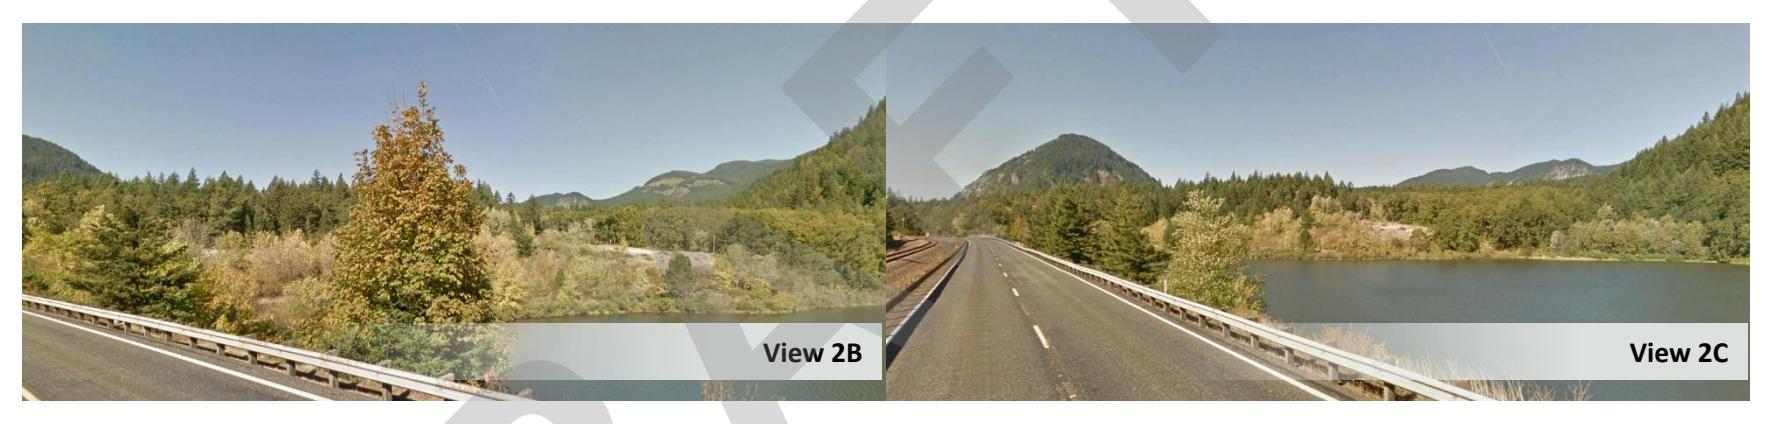
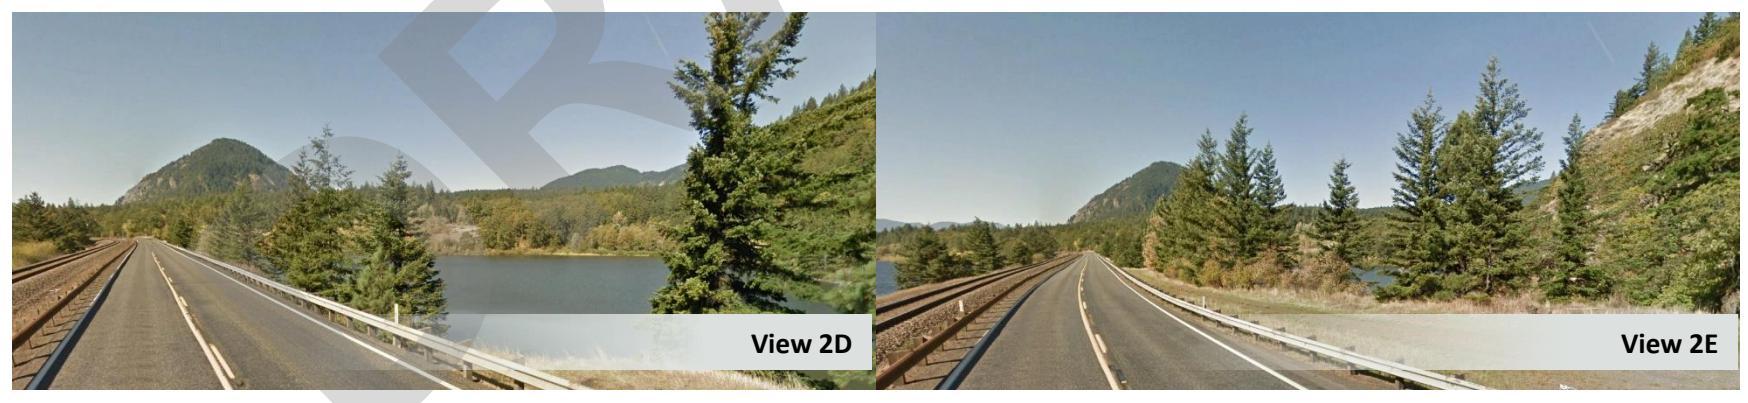
Figure 10. Preliminary Visualization from SR 14

What is provided at this time is the images in Figure 10 (page 24) showing potential viewpoints from SR 14 and the location of a conceptual design (Concept 2 for this example). As shown in the figure, the current landscape shields much of the proposed location. A more refined design is needed to have visuals that may show otherwise.

At this stage of conceptual design, the team does not expect the location of the parking lot to be visible in a conceptual simulation from I-84 or SR 14, due primarily to the terrain obscuring both the actual road and the parking area. A refined design with proposed grading activities and more details about the construction activities, as well as a proper site visit to the location to determine more accurate field conditions, would need to be competed to conduct a proper "leaf off" analysis, as those activities and changes may be visible from SR 14, even if the parking lot itself is not visible (tree removal, grading slopes, etc).
